ST NICHOLAS CHURCH, ASH, CANTERBURY

Diocese of Canterbury

THE PROJECT BRIEF

THE PROPOSALS

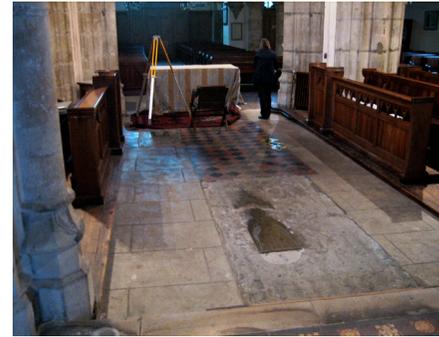
Above left: Tower crossing showing the Clitherow memorial stone, concrete and tiled flooring
Above right: South transept showing pews, organ and stored furniture

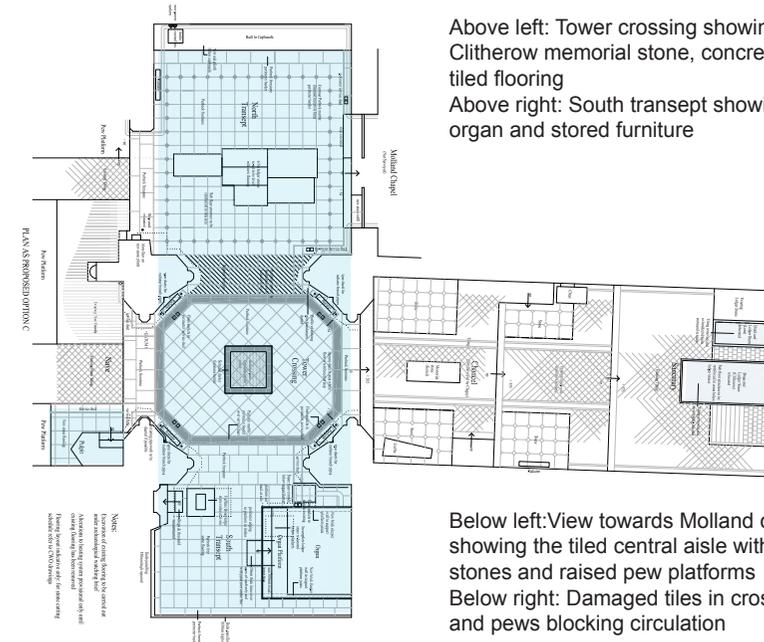
The only way that the spaces could be reordered was for the existing pews and pew platforms to be removed and the flooring replaced, although the platform for the organ in the south transept was retained. The design for the flooring emphasises the central crossing space, with a border of dark Purbeck marble in a chamfered rectangular shape surrounding diagonally laid Purbeck freestone flooring slabs. Both transepts have orthogonally laid flooring slabs with a ring of small diamonds in the darker stone surrounding the memorial stones in the north transept. These reflect the existing pattern of stone flooring in the chancel. The plan shows the new areas of flooring shaded in blue.

The relocation of the two vulnerable 15th century brasses was problematic and the DAC memorials advisor prepared a report on their significance and condition. After much consultation, it was agreed that the best solution would be to relocate them at the east end of the chancel where they would be less likely to be damaged and where there was a comparatively modern tiled floor. These are also shown shaded on the plan.

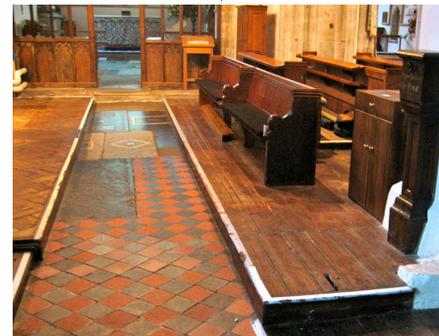
Below left: View towards Molland chapel showing the tiled central aisle with memorial stones and raised pew platforms
Below right: Damaged tiles in crossing floor and pews blocking circulation

The PCC's other principal aim was to reorder the church interior to improve the very limited accessibility in the crossing and transepts for religious services as well as village events such as concerts and harvest lunches. These areas were filled with fixed pews on raised platforms with relatively narrow tiled aisles leading to the chancel and chapel.

This arrangement severely restricted circulation between the nave and chancel and between the transepts, thus limiting alternative use of the spaces. The tiled floors between the pew platforms were uneven, other areas had unsuitable concrete flooring and there were also two important historic brasses in the crossing floor which were in a vulnerable condition. Some of the memorial stones in the north aisle leading up the the chapel were partially obscured by the pew platforms. The juxtaposition of different floor finishes and levels as well as the bulky and dark pews created a visually cluttered and inflexible space.

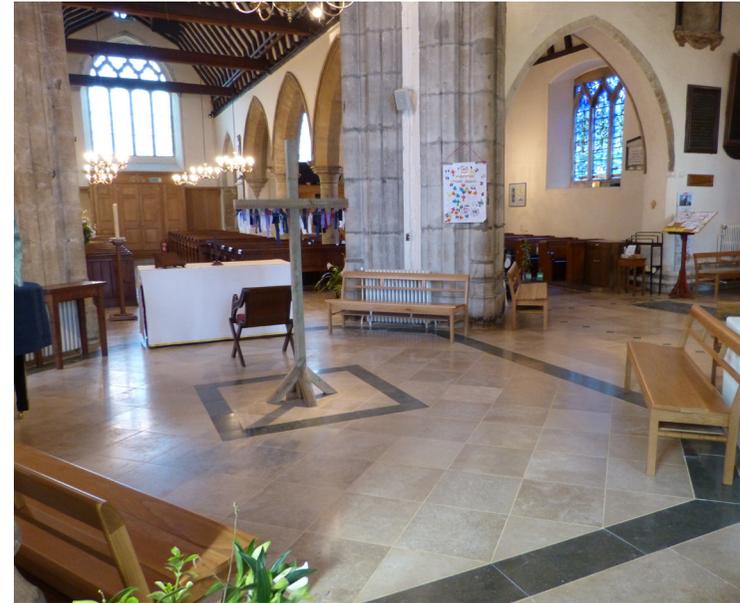
View of crossing looking towards nave and north transept

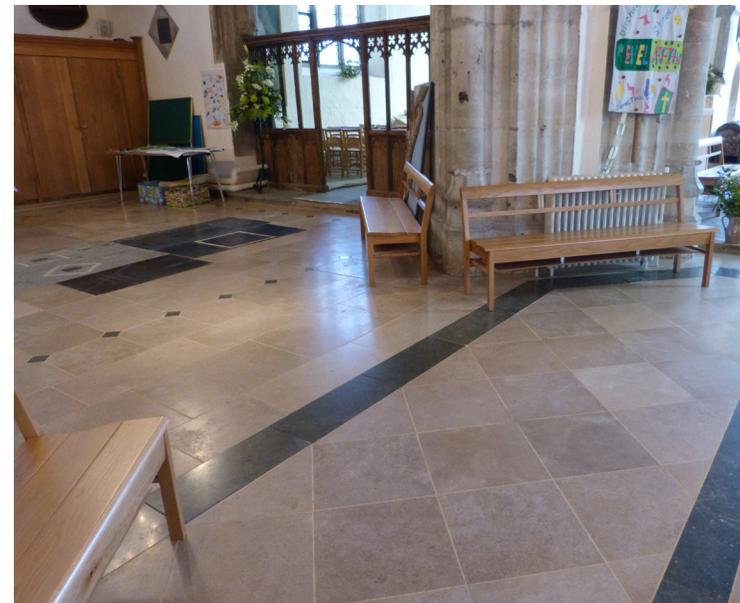
View from crossing towards Molland chapel

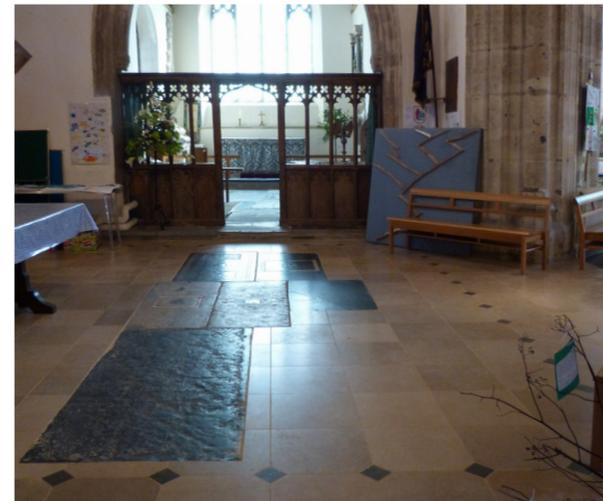
Floor memorials and border in north transept

Whilst the relaying of the memorials in the north transept was relatively straightforward, a large brick vault was discovered under the south transept containing a number of lead coffins which had to be recorded by the archaeologists. As it was so near the floor surface, the new floor construction thickness over it was reduced to a minimum. Also, when preparations were being made to the existing floor in the chancel to receive the relocated memorials, the floor structure started to collapse inwardly, revealing large voids and these had to be filled with a considerable quantity of lime grout to provide a stable base for the memorials. This additional work caused some delays and increased costs to the contract.
